Preventing Building Collapse

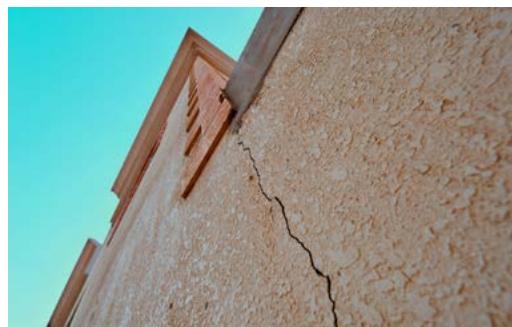
Figure 1: Significant Cracking

Look for visible signs of damage or structural deformation, such as cracks, leaning walls, roof deflection (bending), or uneven floors. Many cracks occur normally as concrete ages. However, when you see exposed (and rusted) steel or rebar reinforcement that was originally inside the concrete, it's time to bring in an expert, such as a licensed structural engineer, to determine if the structure remains safe or needs repair.

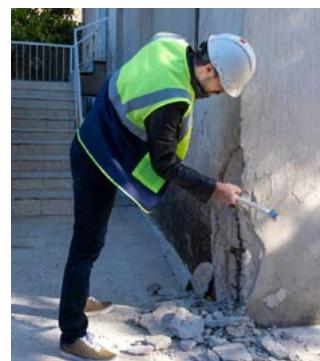
Figure 2: Exposed Rebar

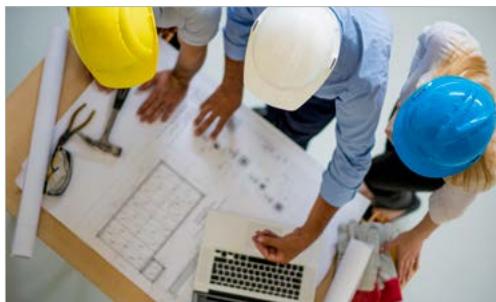
Figure 3: Change in Occupancy

Consider changes from the building's original intended use. If the occupancy has changed - such as from a retail space to a storage warehouse, or from a residential space to a manufacturing space – then a structural review is necessary. When occupancies change, structural load requirements may also change, warranting review by licensed structural engineers.

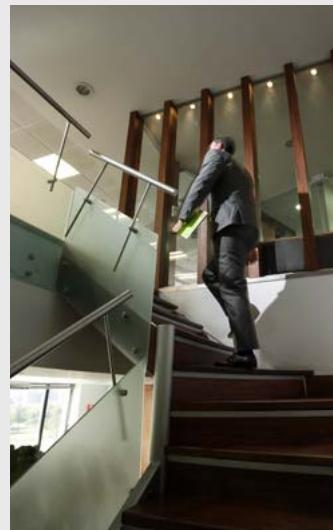
Figure 4: New Interior Stairway

Identify areas where distress is expected and the structural building element is visible. Potential scenarios include previous structure features or floors being removed, new floors being added vertically, new interior stairways penetrating existing floor slabs, or new building-mounted solar panels or green roofs being planned or recently installed. In such cases, ensure an engineering analysis is completed and look for signs of distress at the main beams, columns, and walls.

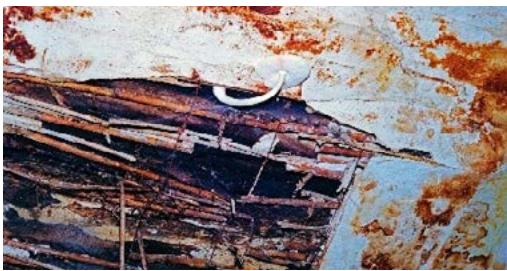
Figure 5: Rust and Corrosion

Corrosive environments warrant special attention. Operations and areas that create humid, caustic, or acidic environments (e.g., electroplating, pickling, anodizing, chemical blending, etc.) can result in accelerated corrosion of structural steel members, bracing, bolted connections, and structural metal decks.

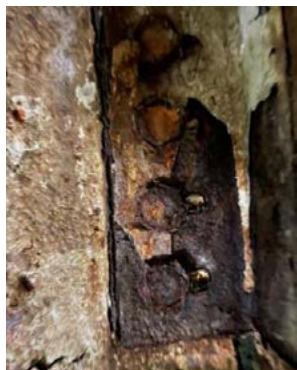
Figure 6: Highly Deteriorated Bolted Connection (CARTA Advisors, LLC)

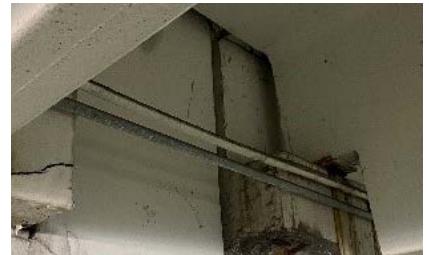
Figure 8: Exposed Rebar

Parking structures are particularly susceptible to collapse as they are exposed to weather. Look for formal snow removal plans and procedures reviewed by a structural engineer. Ensure weight and height restriction signs/bars are installed at access points. The best practice is to complete a thorough structural audit by licensed engineering professionals every three years to address critical deficiencies.

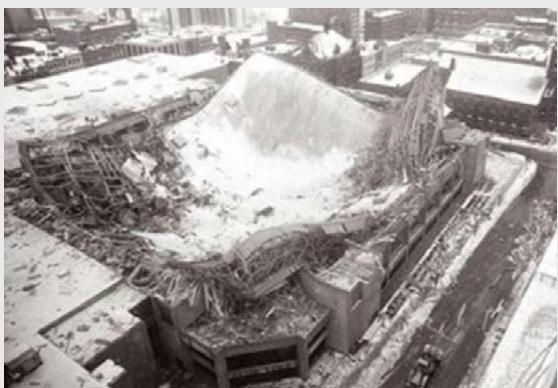
Figure 9: Collapse from Snow (CARTA Advisors, LLC)

Excessive snow loading can cause the collapse of any building. Signs of distress include sagging roof beams, cracked or split wood roof members, sprinklers pushed down below ceiling tiles, and doors or windows that are difficult to open. Listen for creaking, groaning, cracking, popping, or other unusual noises from the building. In such cases, immediately evacuate the building and contact a licensed structural engineer.

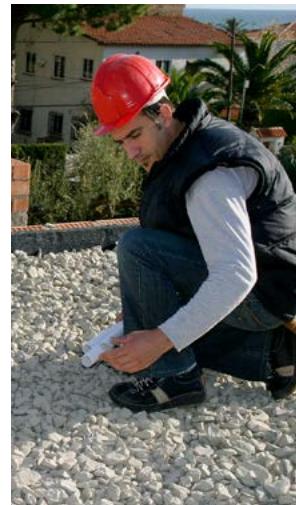
Figure 10: Roof Inspection

Well-maintained roofing systems are key to keeping out water and helping to prevent collapse. Routine roof inspection by a qualified roofing contractor is fundamental to the early identification of deficiencies – from blocked gutters/downspouts to open penetrations, tears, seams, and standing water, to name a few. Exposed rooftop structural steel is especially important to review, including large signage, billboards, and the like. Formal roof preventative maintenance programs and routine inspections are critical.

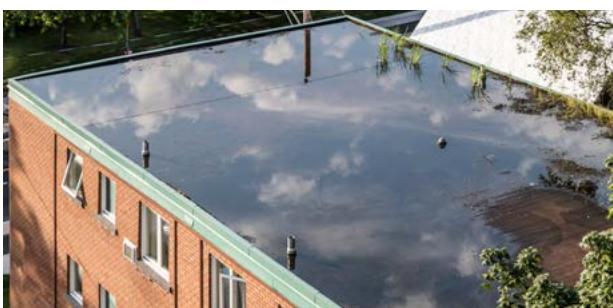
Figure 11: Poorly Drained Roof

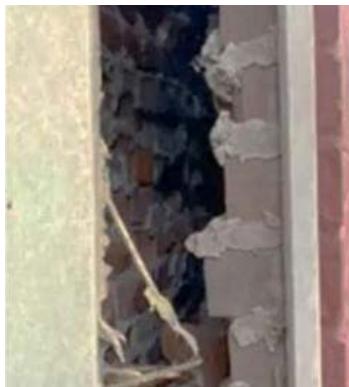
Figure 12: Masonry Wall at Risk of Collapse (CARTA Advisors, LLC)

Aging exterior masonry walls warrant special attention. Water intrusion into structural masonry walls can quickly result in collapse. Look for cracked and open mortar joints, loose/displaced fallen bricks/tiles/terra cotta, rust stains (where steel reinforcement may be behind), etc. Aging and failed sealant joints will need to be addressed.

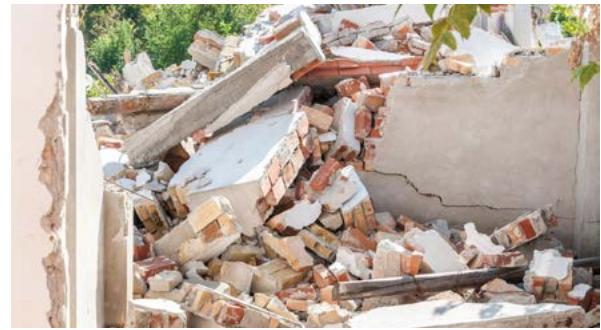
Figure 13: Collapsed Masonry Wall

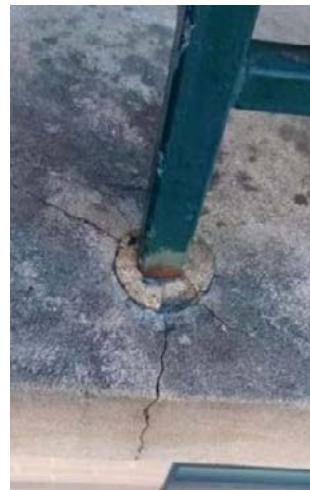
Figure 15: Cracking on Cantilevered Balcony Railing

Balconies can present extraordinary collapse risk. Cantilevered concrete balconies, exposed to the weather, can rapidly deteriorate as the result of water intrusion into the slab and structural components. Look for cracking, loose railings, and signs of poor drainage, and perform annual visual inspections.

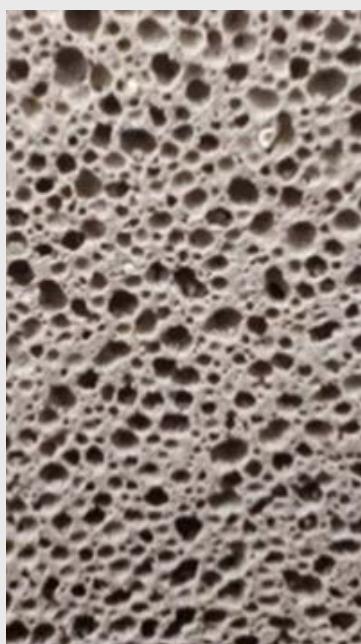
Figure 16: Close-up of RAAC (Loughborough University²)

Life-expired construction materials, such as older (before 1990) reinforced autoclaved aerated concrete (RAAC), are highly porous and prone to crumbling and collapse – especially when used as roofing planks.²

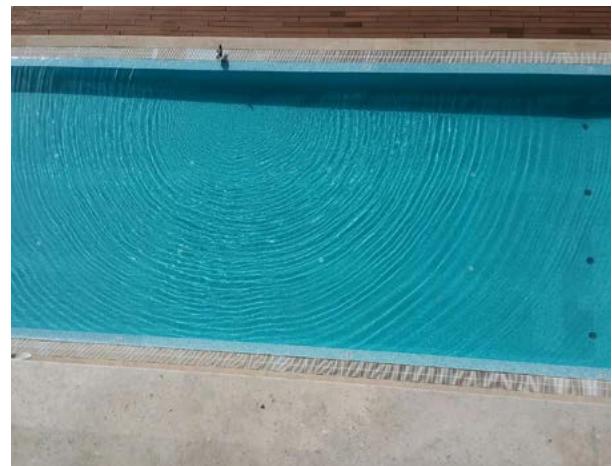
Figure 17: Rooftop Pool

Elevated and rooftop swimming pools, when improperly waterproofed or designed, can result in collapse exposure—especially when designed with water treatment areas directly underneath.
